Civil Unrest & Arson

18 June 2010

CE-2010-000113-KGZ

EMERGENCY ANALYSIS 2: SATELLITE-BASED QUALITATIVE DAMAGE ASSESSMENT SUMMARY FOR OSH, KYRGYZSTAN

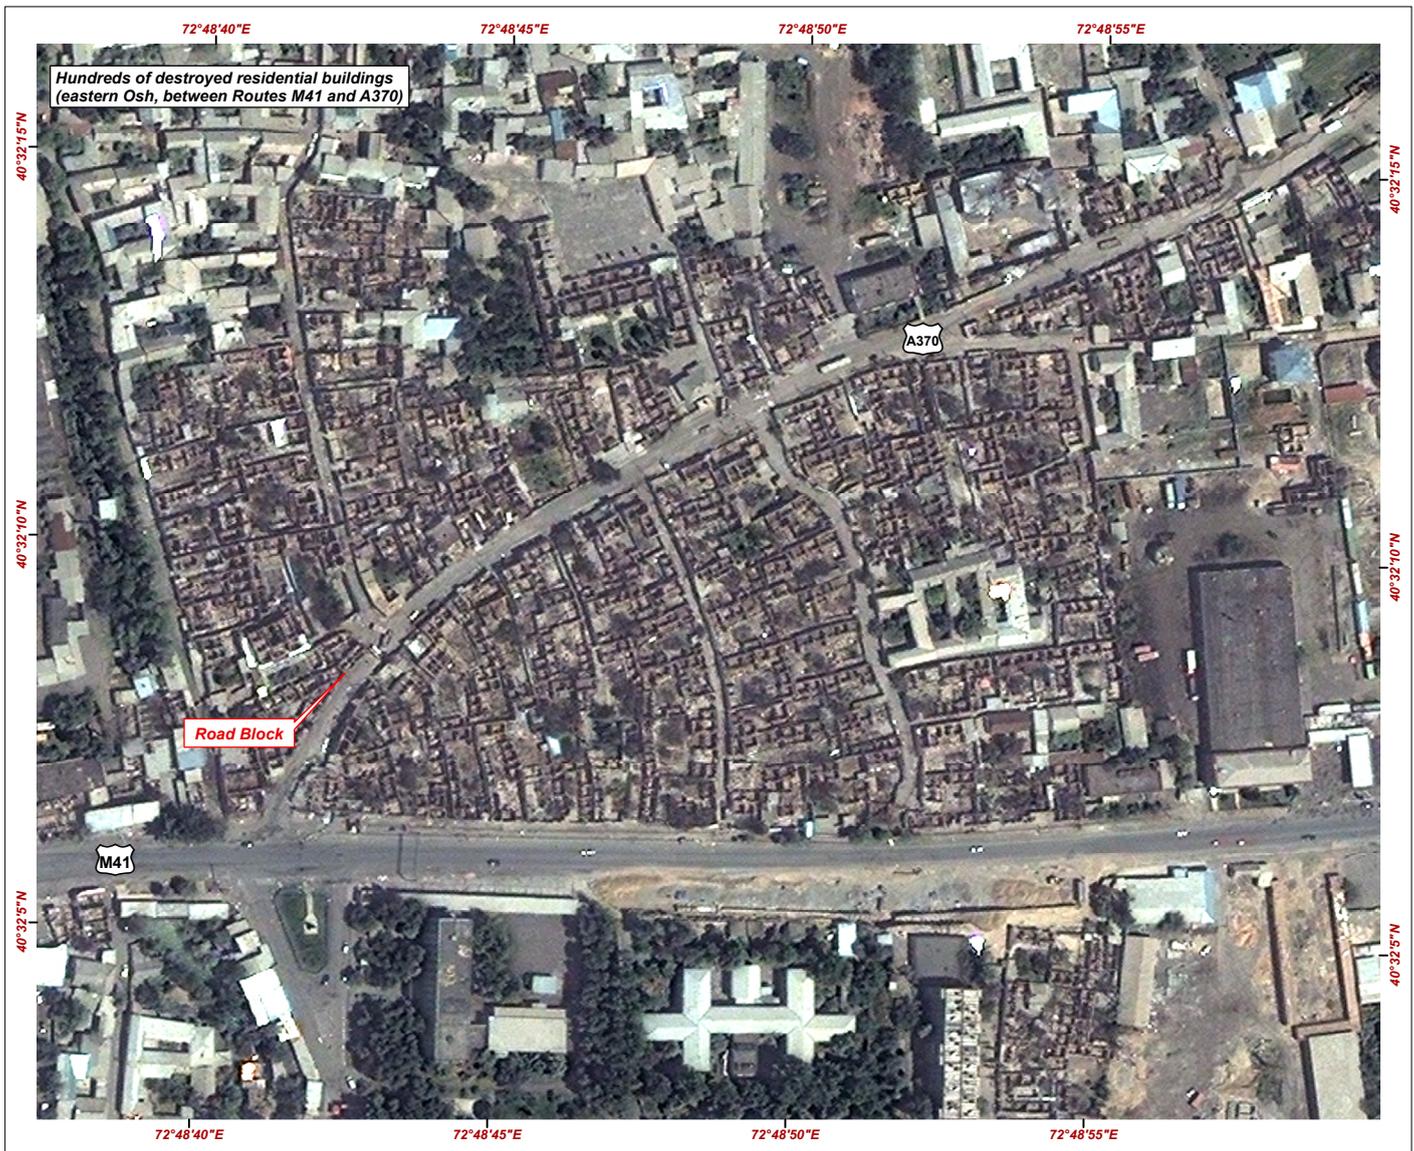
This is an initial, qualitative damage summary for the city of Osh, based on crisis satellite imagery acquired the morning of 18 June 2010. Within the city there are multiple sites of near total building destruction which is likely to total in the low thousands (approximately 2-3,000). West of the Osh River, immediately north and south of the Sulyaman Mt. Park there are three major clusters of building destruction (est. hundreds). The majority of building destruction in the city however, is concentrated east of the Osh River, between the neighborhoods of Manas-Ata and Kalinin, divided by the main route of M41. There are multiple areas of near total building destruction with clearly defined boundaries between affected and unaffected neighborhoods. The largest concentration of building destruction is located at the intersection of

the main routes M41 and A370 (see image below). A preliminary assessment of building damage signatures indicates that arson was the probable cause because of the prevalence of destroyed rooftops with visibly intact load-bearing walls, a common signature of fire-related damages; a finding supported by the satellite detection of 5-6 active fire zones within the city at 6:25 UTC (12:25 local time) on 12 and 13 June 2010 (see UNOSAT Emergency Analysis 1). Almost all affected buildings appear to have been residential or situated within residential neighborhoods, however there are a few cases of destroyed or severely damaged industrial warehouses or commercial / government facilities. No damages have been observed to the transportation network (e.g. roads, bridges) or other key infrastructure sites within the city; however there are
