# UNOSAT

## SITUATION UPDATE FOR KOBANI, ALEPPO GOVERNORATE, SYRIAN ARAB REPUBLIC

Based on satellite imagery acquired 15 October 2014

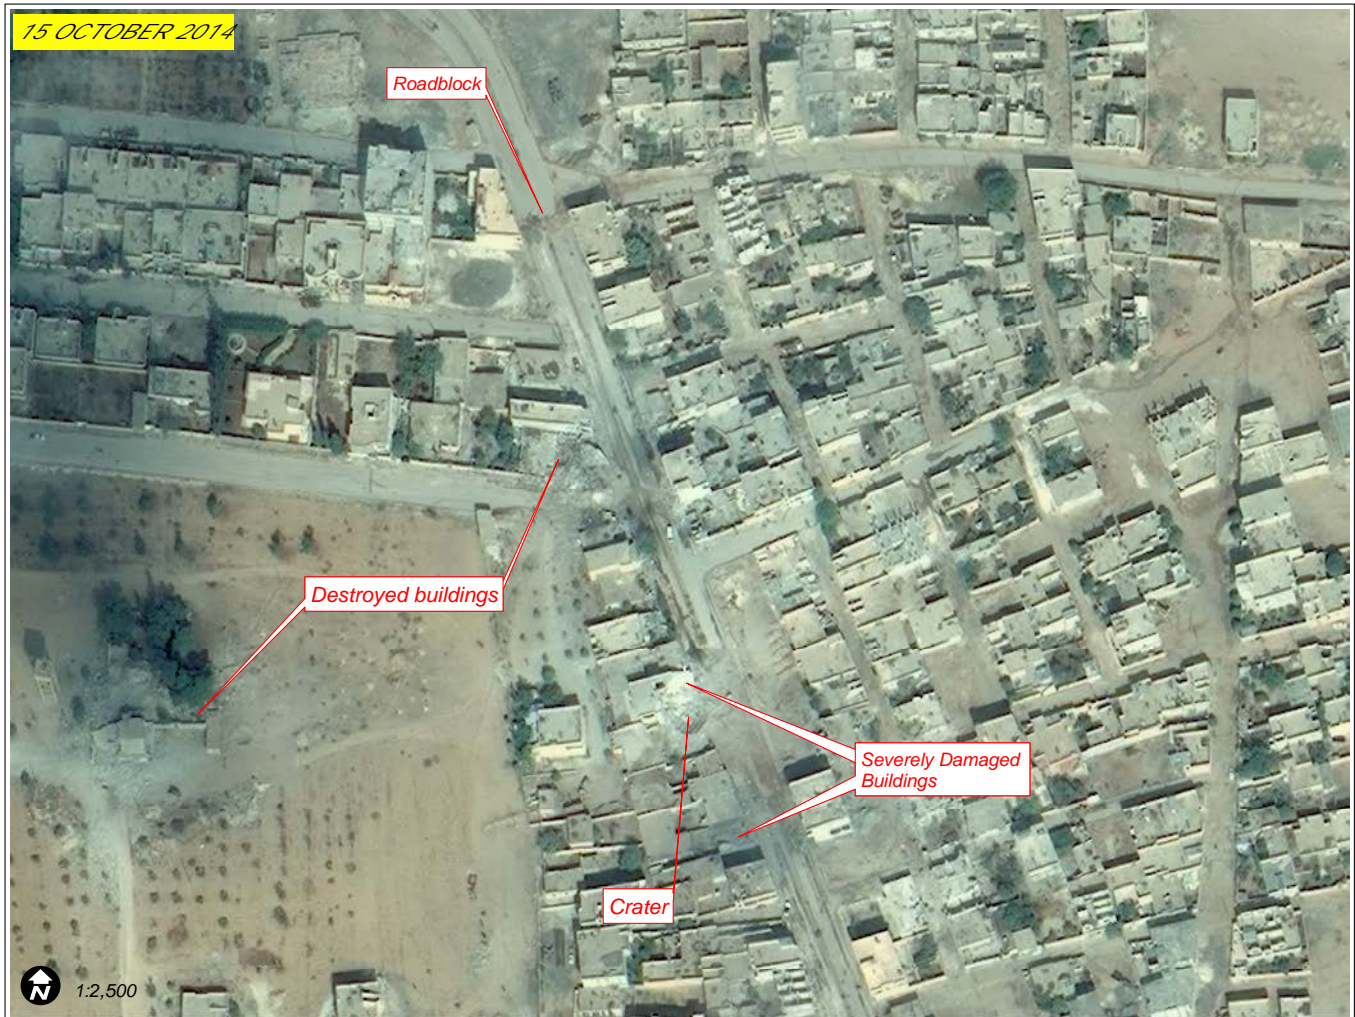
The image shows destruction at the eastern part of the city of Kobani. Several buildings appear destroyed or heavily damaged; craters and roadblocks are also visible.

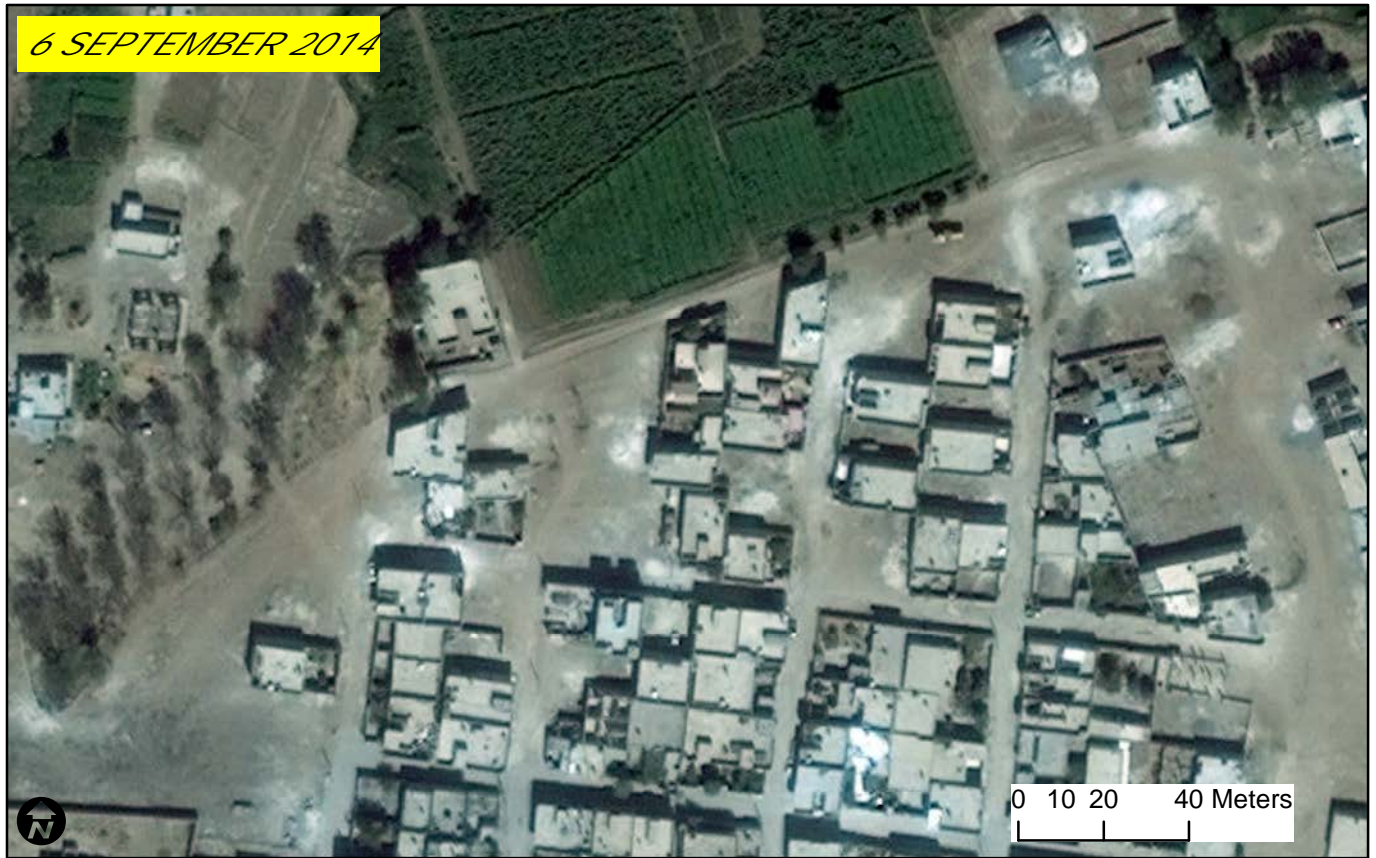
*Figure 1: Destroyed and damaged structures in Kobani*

*The figure shows a portion of the northern part of the town of Kobani where several buildings are destroyed or severely damaged (blue arrows), possibly by air strikes. A large crater is also visible next to the damaged structures (red arrow). Images copyright 2014 DigitalGlobe.*

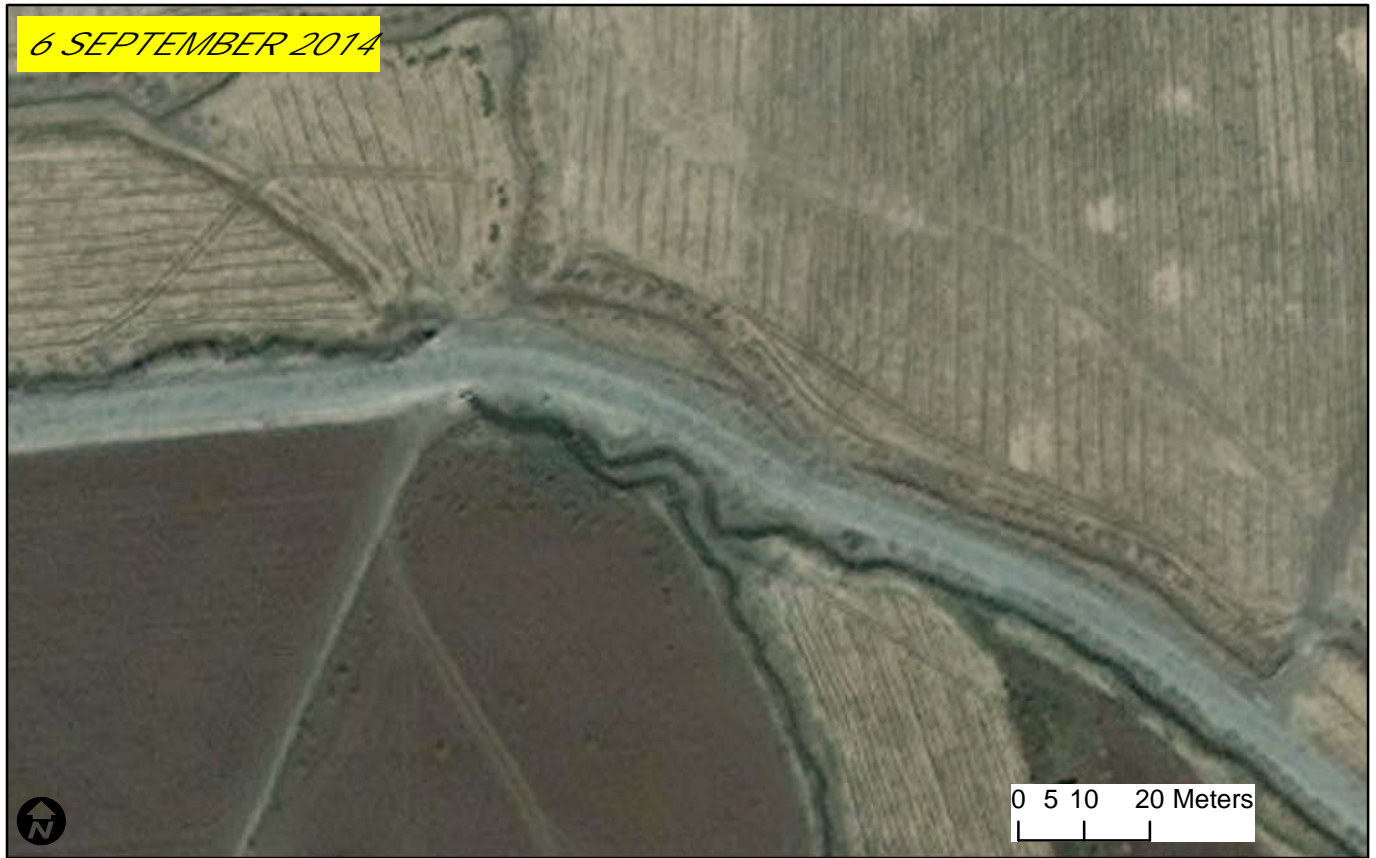
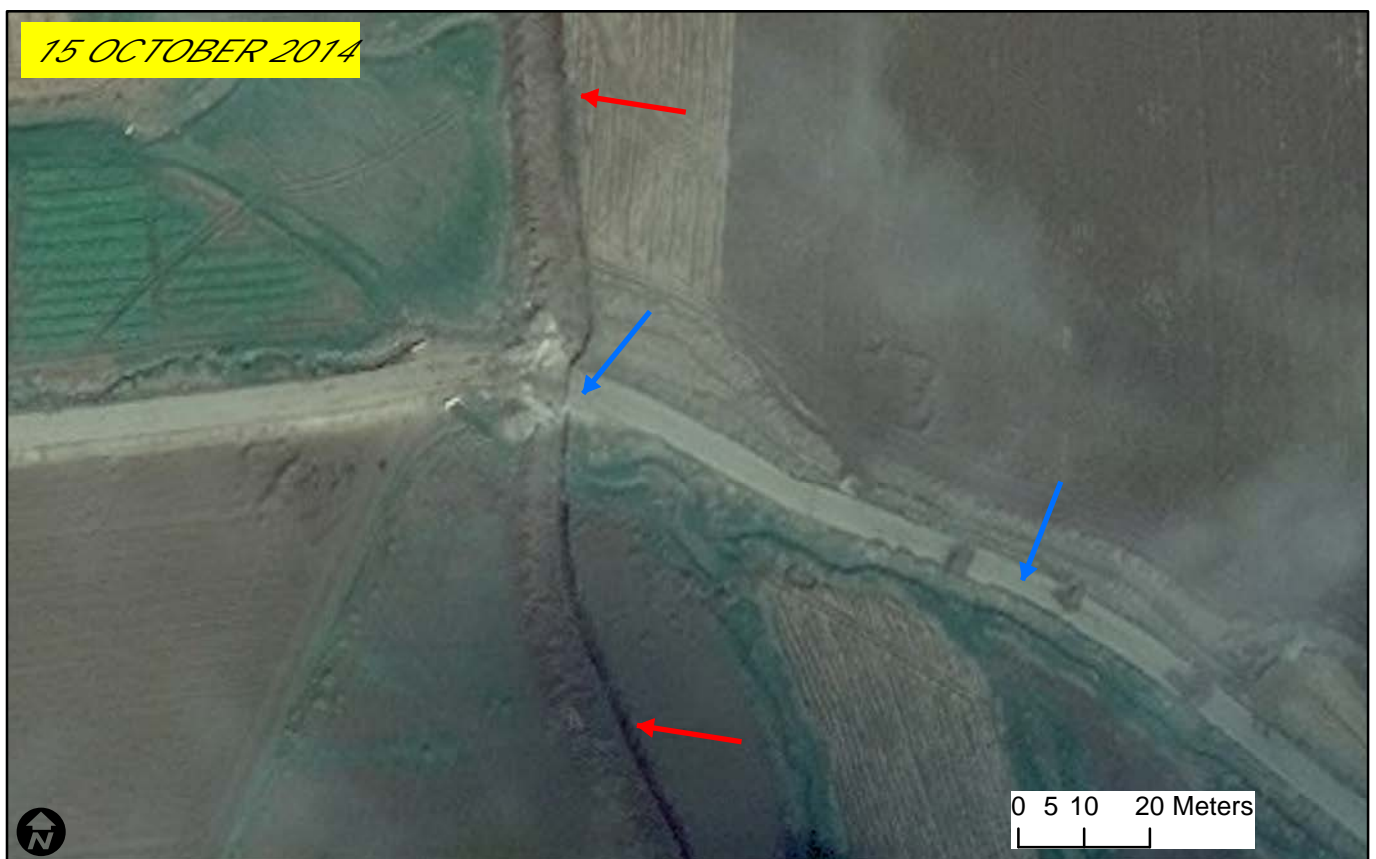
*Figure 2: Roadblocks and fortified fighting line*

*Imagery shows roadblocks and access control points placed along the roads preventing access to the town (blue arrows). A probable fortified fighting line is also visible in the imagery (red arrow). Images copyright 2014 DigitalGlobe.*

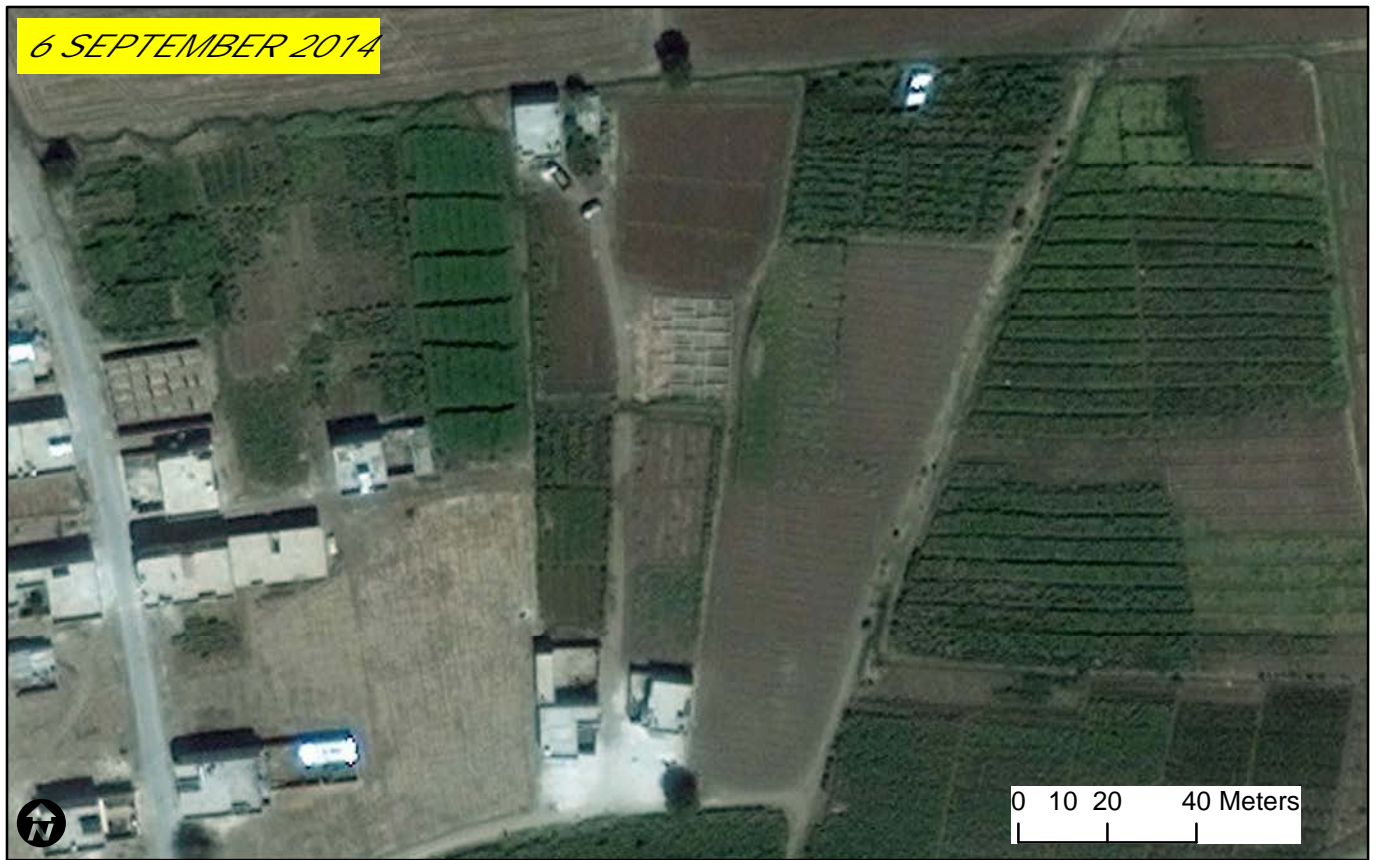
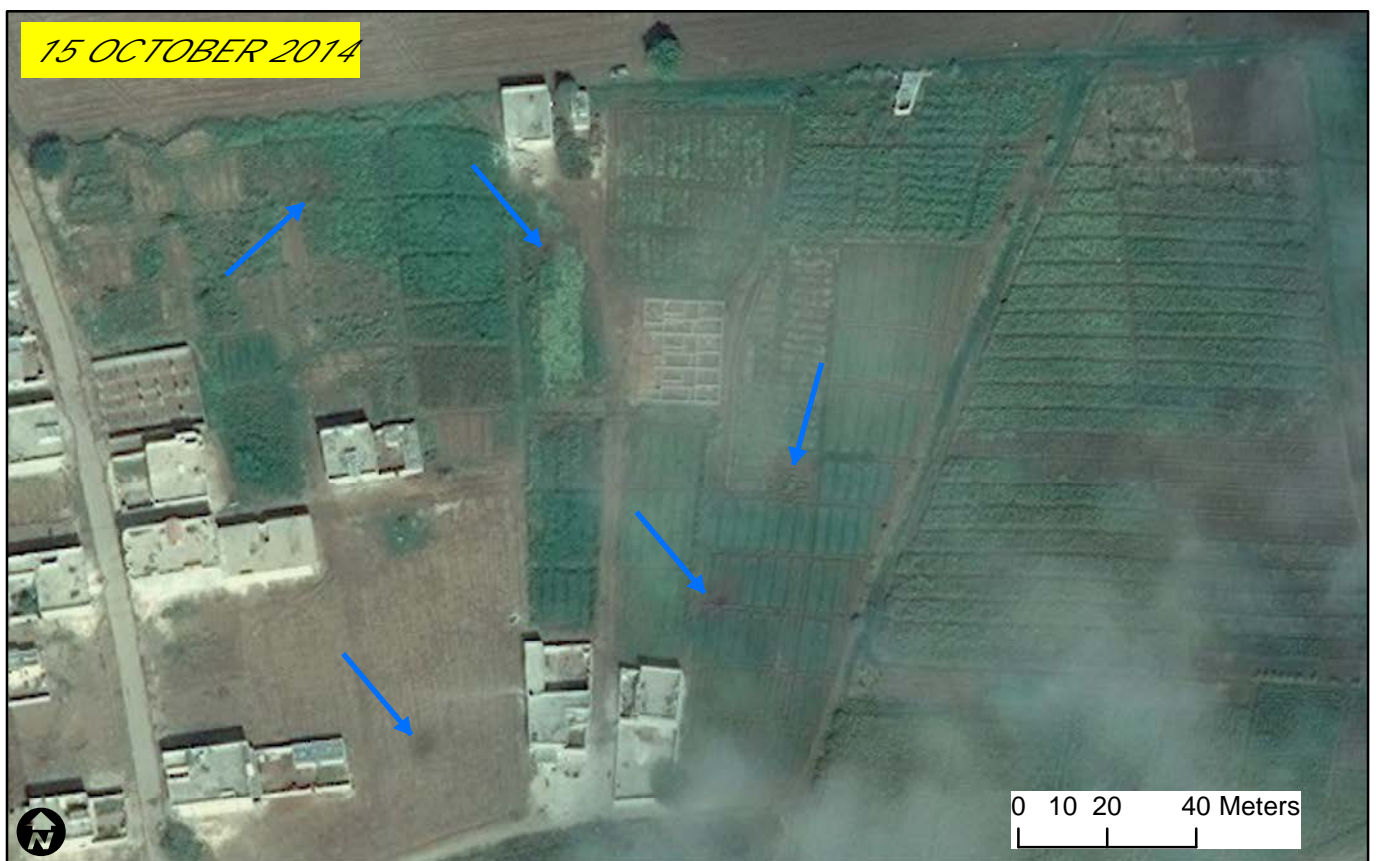
*Figure 3: Munitions impact craters on fields*

UNOSAT also detected numerous munitions impact craters on the fields (blue arrows) in and around Kobani. Images copyright 2014 DigitalGlobe.

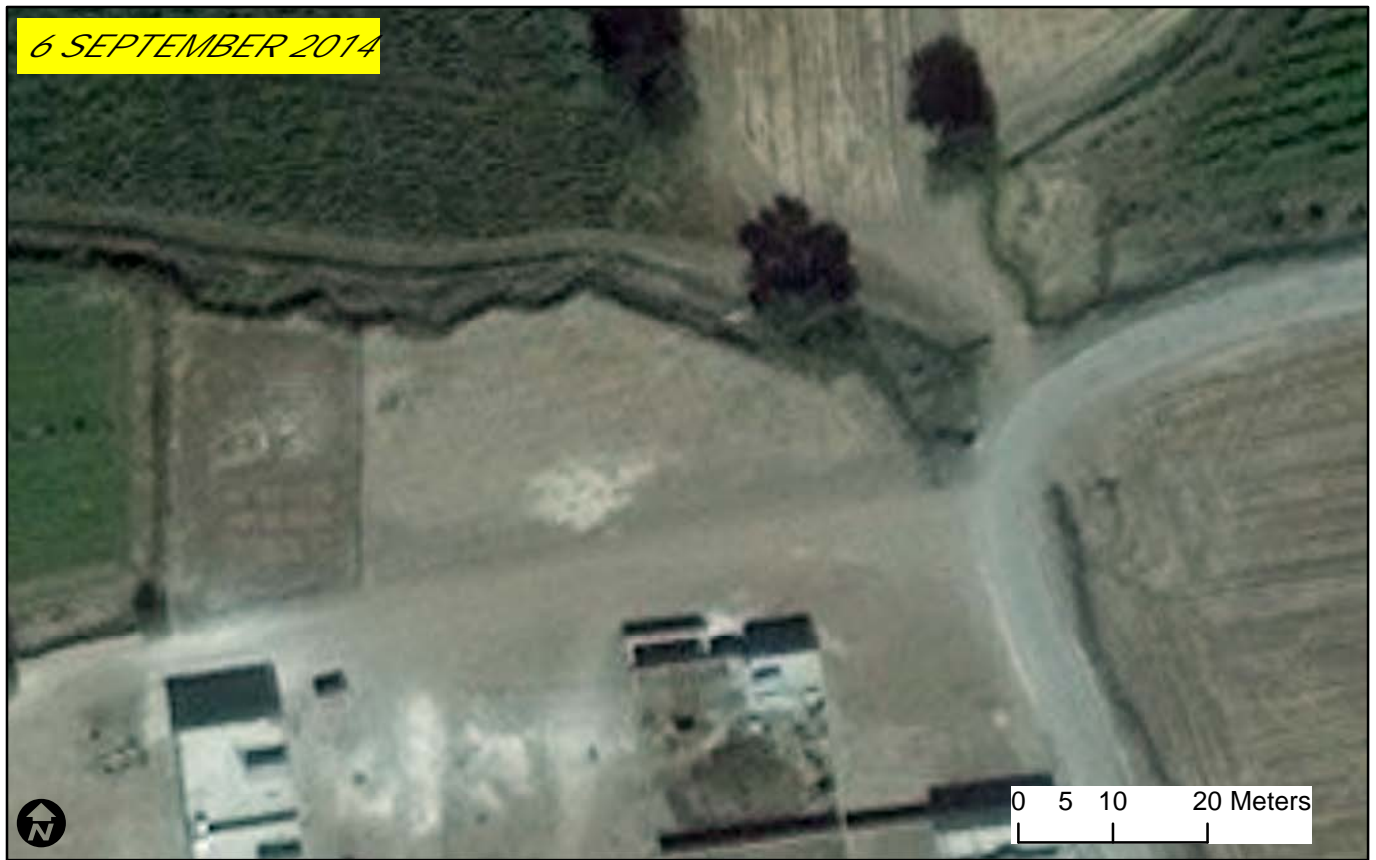
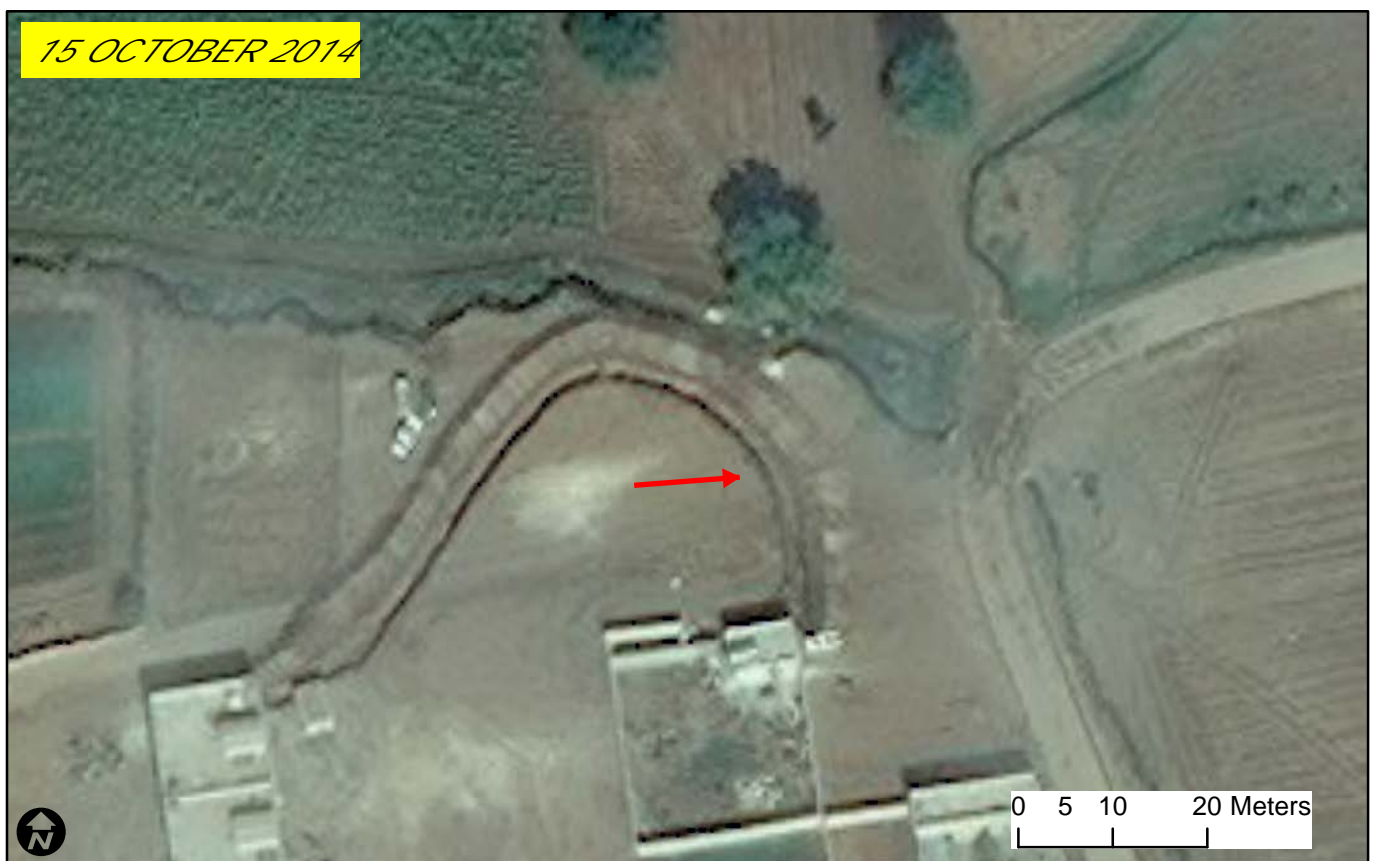
*Figure 4: Fortified fighting position*

*A fortified fighting position is visible inside of the town (red arrow) in the proximity of an access road with restricted access. Images copyright 2014 DigitalGlobe.*

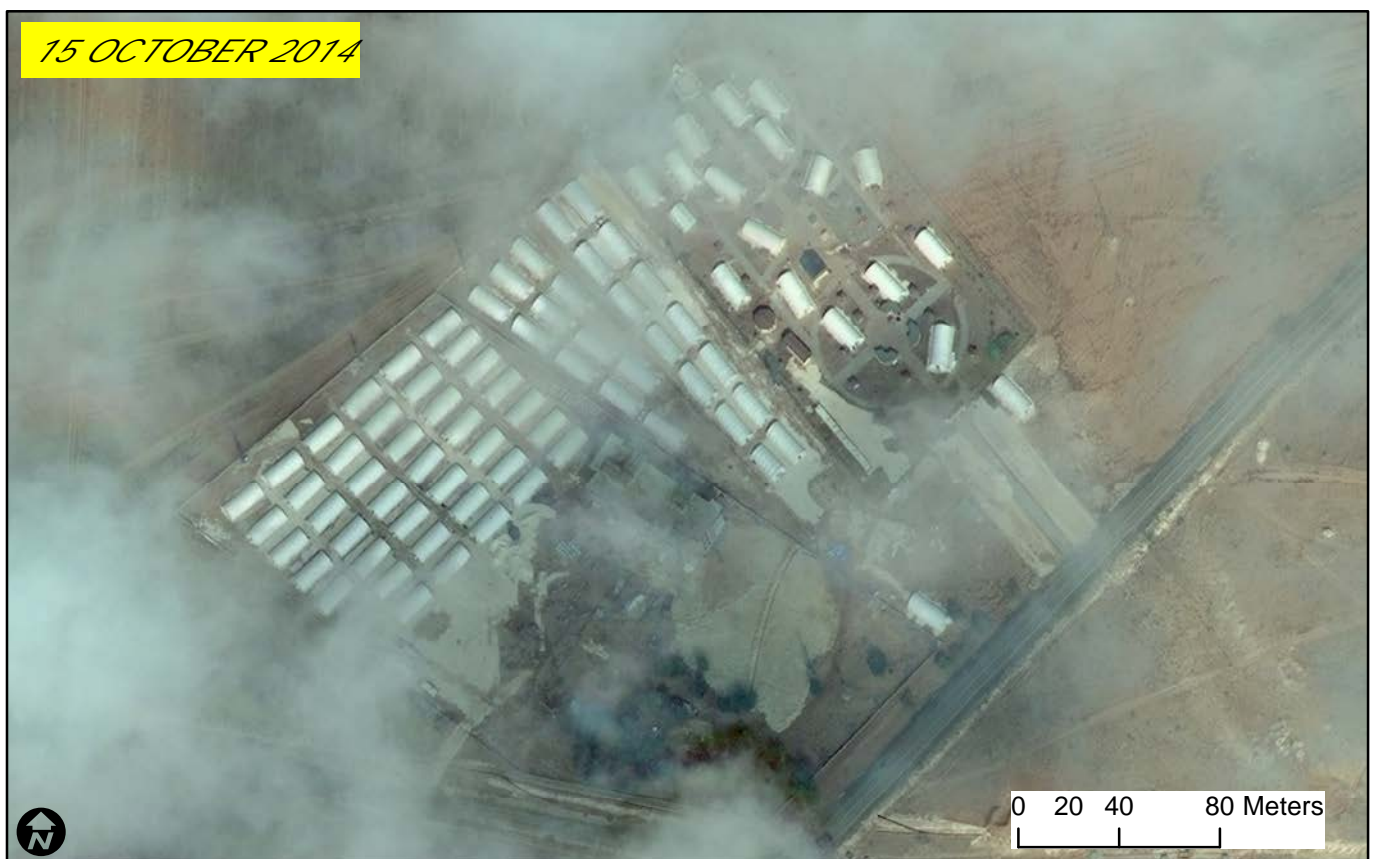
*Figure 6: Newly constructed refugee settlement*

*Close to the border, on the Turkish side a refugee camp has been created in order to accommodate increased number of refugees fleeing Kobani. Images copyright 2014 DigitalGlobe.*
