IMAGERY ANALYSIS: 20 & 22 March 2022 PUBLISHED: 30 March 2022 V1

This map illustrates a satellite imagery-based Rapid Damage Building Assessment (RDBA) in Sumy City, Ukraine. The RDBA divides the city into 500m x 500m cells, each of which is analyzed to determine whether or not there are damaged buildings inside the cell.

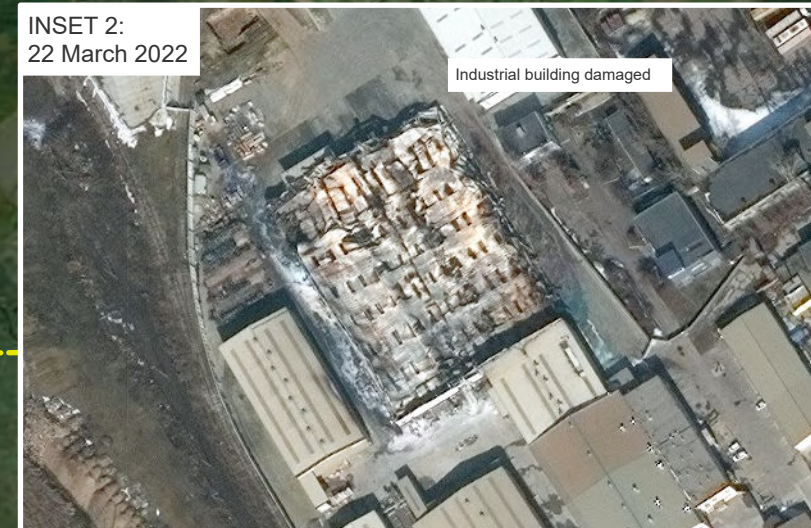
Based on imagery collected on 20 and 22 March 2022, analysts found that 5 cells out of 1,111 cells sustained visible damage. This represents approximately 0.4% of the cells over the city.

This analysis is based on structures visibly damaged as of 20 and 22 March 2022 as seen in marginally degraded satellite imagery affected by precipitation, seasonality, and other limiting factors. This is a preliminary analysis and has not yet been validated in the field. Please send ground feedback to United Nations Satellite Centre (UNOSAT).
