UKRAINE

CHERNIHIV CITY, CHERNIHIVSKA OBLAST

IMAGERY ANALYSIS: 22 March 2022 PUBLISHED: 02 April 2022 V1

UNOSAT Damage Assessment Overview Map

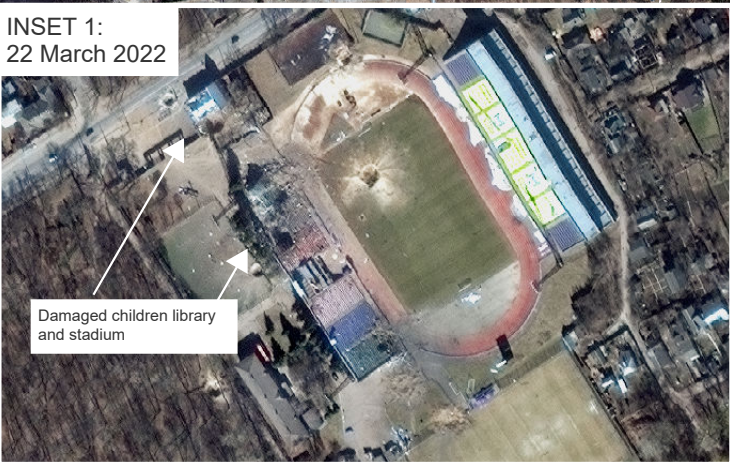
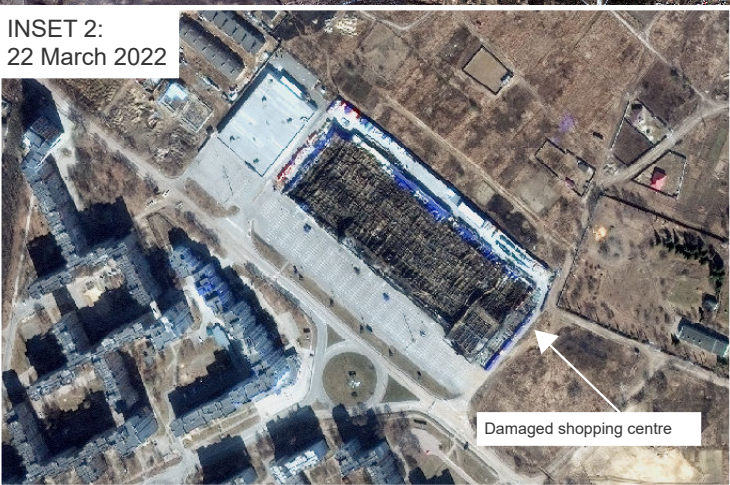
This map illustrates a satellite imagery-based Rapid Damage Building Assessment (RDBA) in the Chernihiv City, Ukraine. The RDBA divides the city into 500m x 500m cells, each of which is analyzed to determine whether or not there are damaged buildings inside the cell.

Based on imagery collected on 22-March 2022, analysts found that 191 cells out of 901 cells in the City of Chernihiv sustained visible damage. This represents approximately 21% of the cells over the city.

This analysis is based on structures visibly damaged as of 22 March 2022. This is a preliminary analysis and has not yet been validated in the field. Please send ground feedback to United Nations Satellite Centre (UNOSAT).
