# REPORT: CYCLONE EVAN DAMAGE ASSESSMENT OF APIA, TUAMASAGA DISTRICT, UPOLU ISLAND, SAMOA

02 January 2012 – Version 1

## Report: Cyclone Evan Damage Assessment of Apia City, Samoa

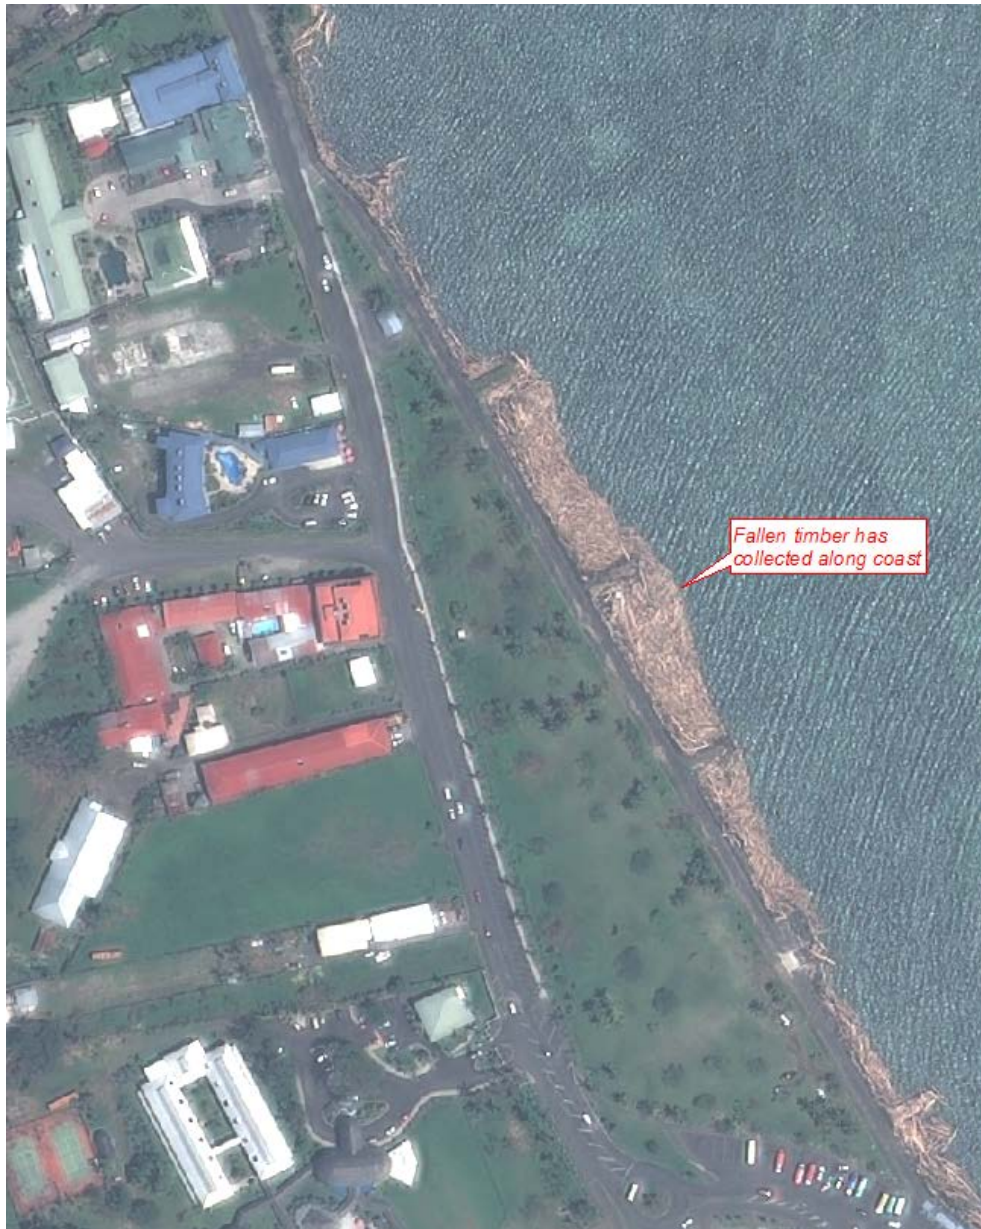
### 1. (Site 1) Fallen timber and other debris have collected along the coast.

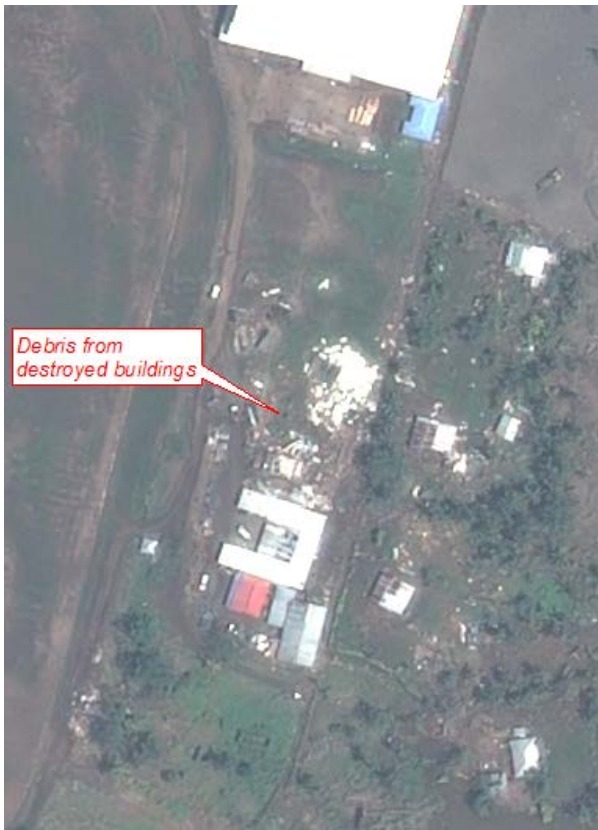
Site 2

2. (Site 2 & 3) In site 2 there are structures with visible damages, sections of roof missing and two buildings apparently destroyed (evident from the debris concentrations). In site 3, a building with severe damages appears to have partially collapsed.

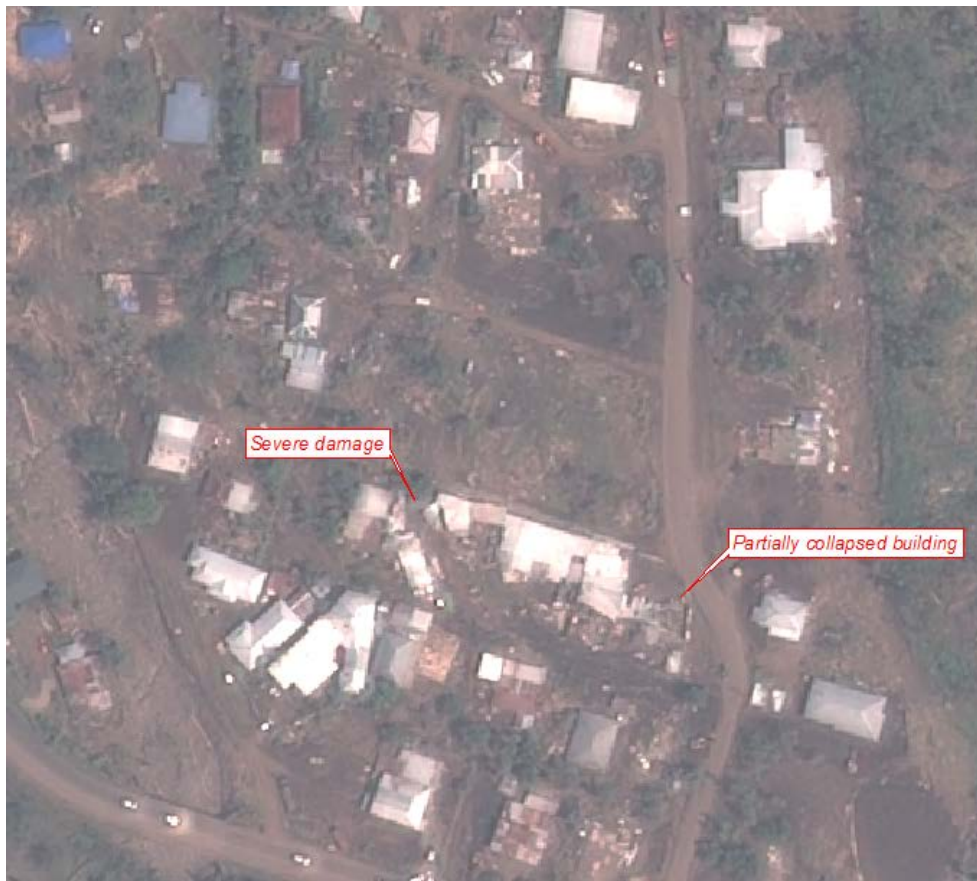
3. (Site 4) Structures severely damaged with sections of roof missing. Potentially partially collapsed buildings.

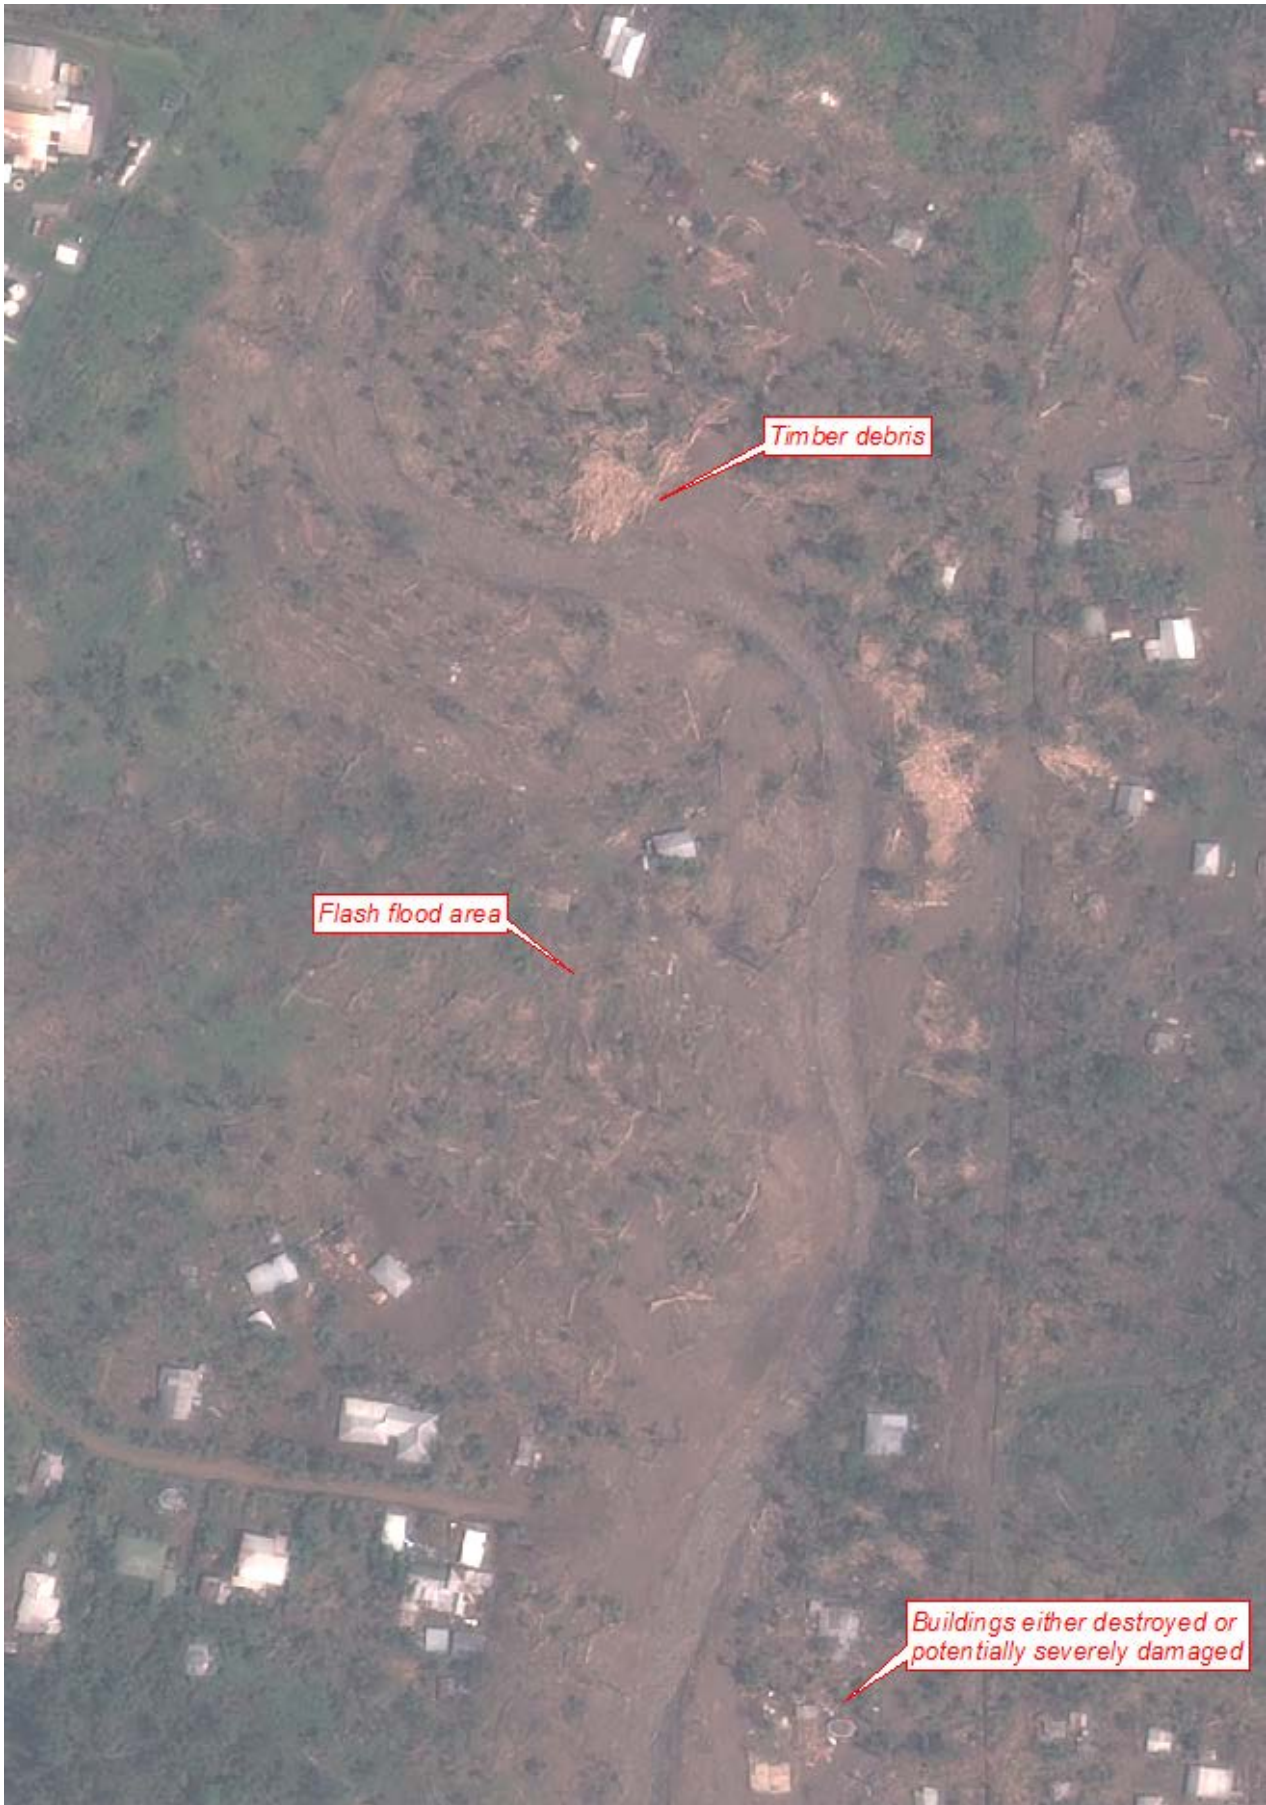
4. (Site 5) Mud and debris mark the overflow of the river and potential flash flood in the area. Debris appears to be mainly fallen timber in this area, likely from windblown forests up the river. Buildings in this area are likely damaged.
